**Appraisal Report # [REDACTED]**

**1971 Ford Torino GT Sportsroof**

This report has been prepared for [REDACTED]

A vehicle inspection and report preparation undertaken by:

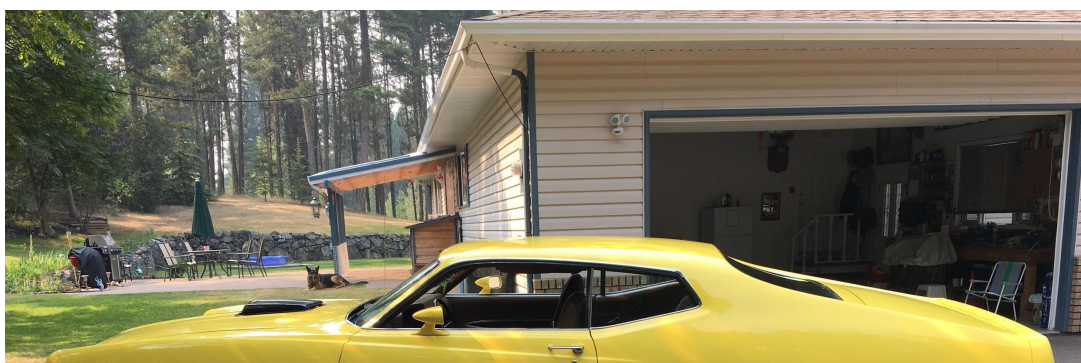
Paint shines, excellent fit and panel gaps

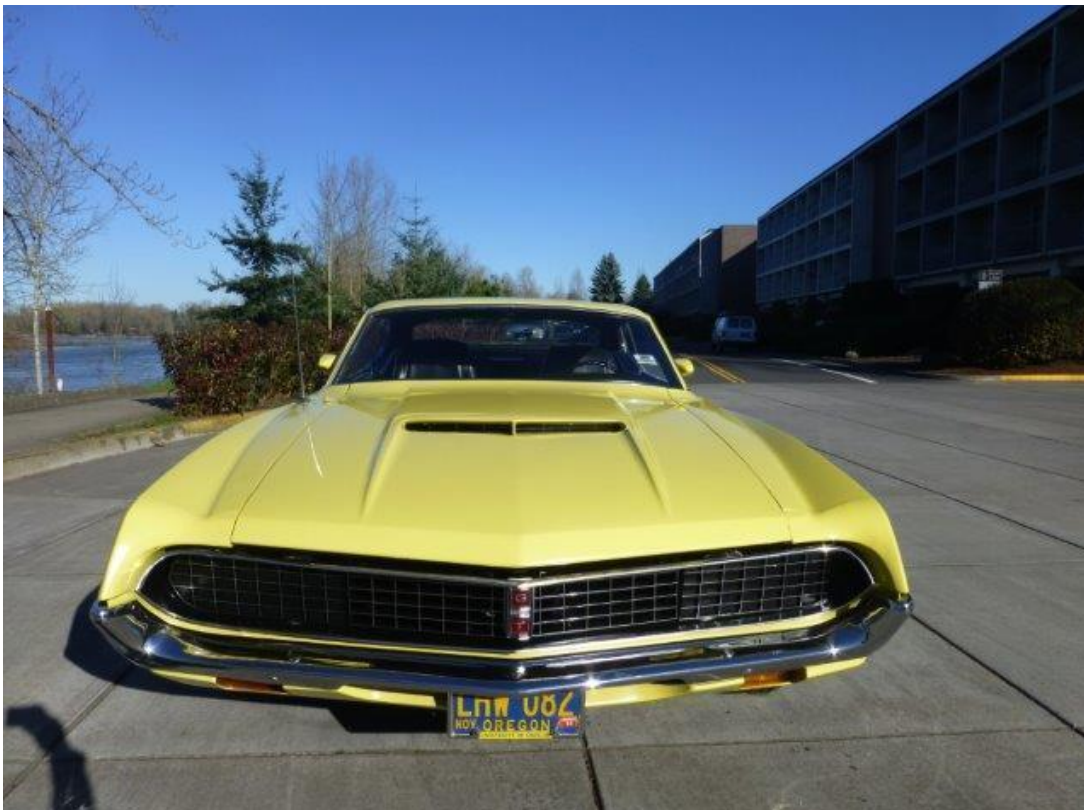
Excellent grill detailing, bumper straight and smooth

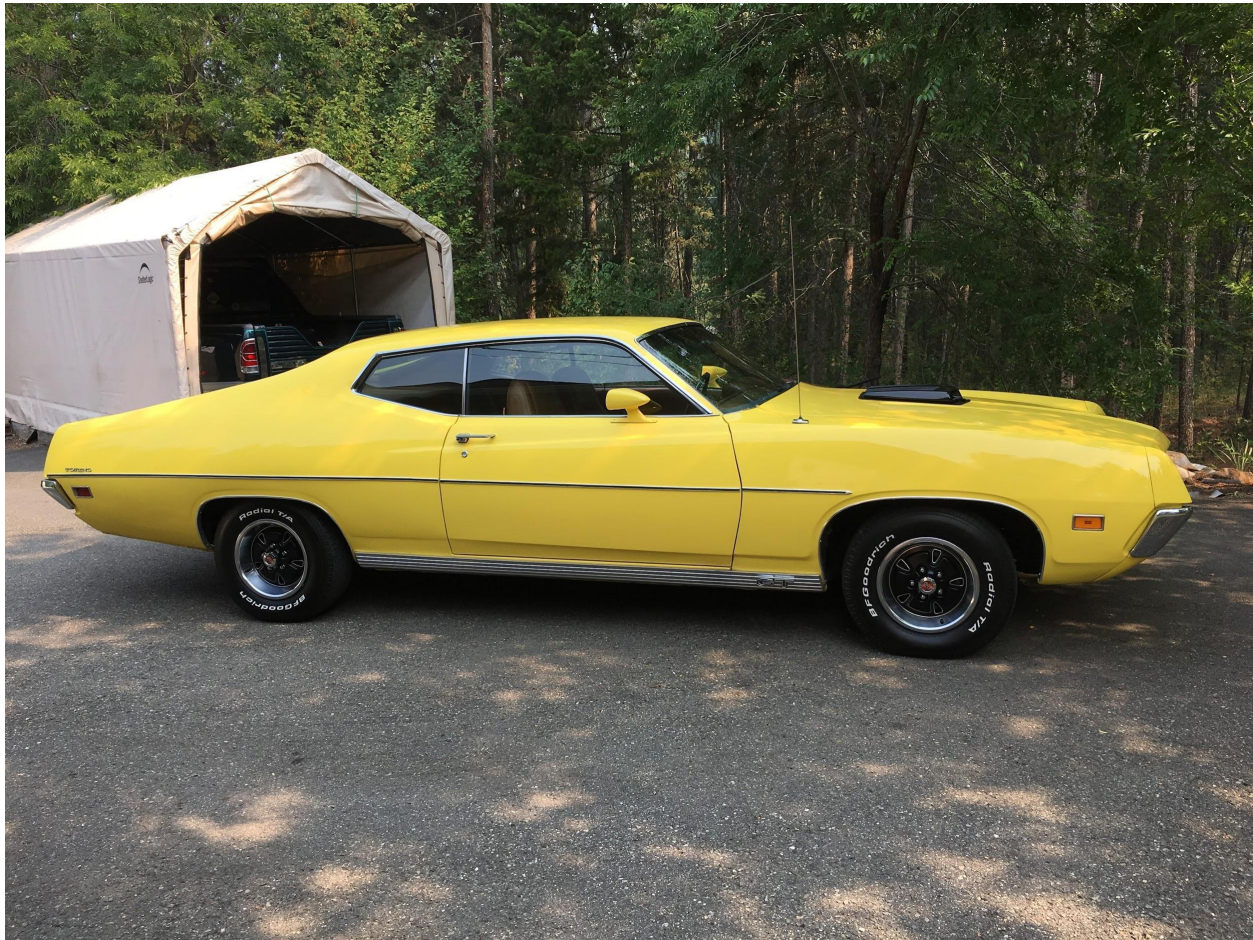
GT options include Shaker hood, side moldings and Sports Wheel Covers

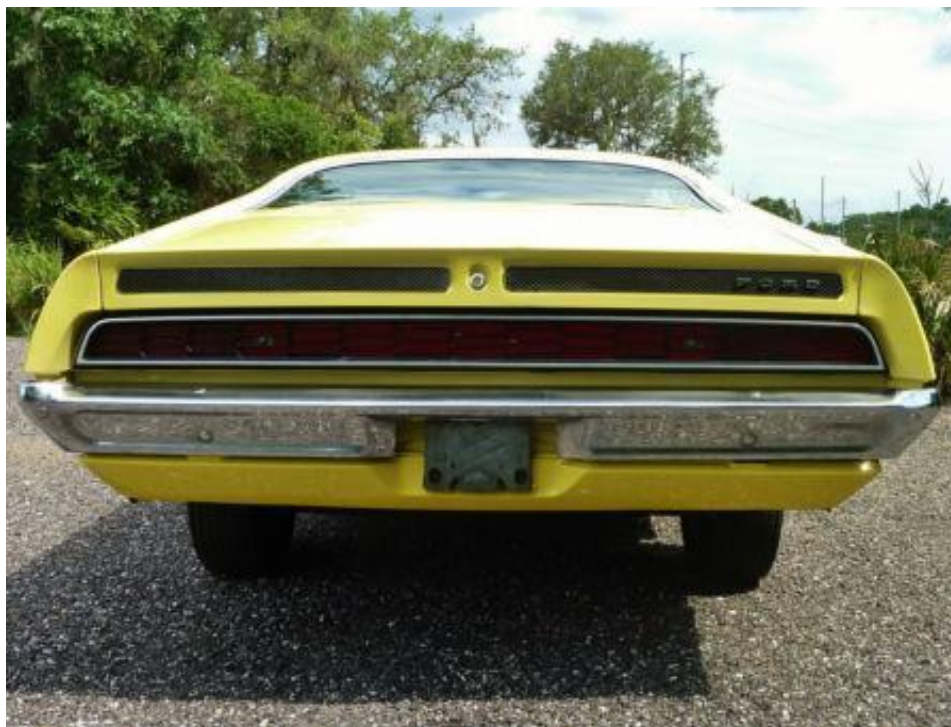
Good gaps, fit and finish under bumper, alignment

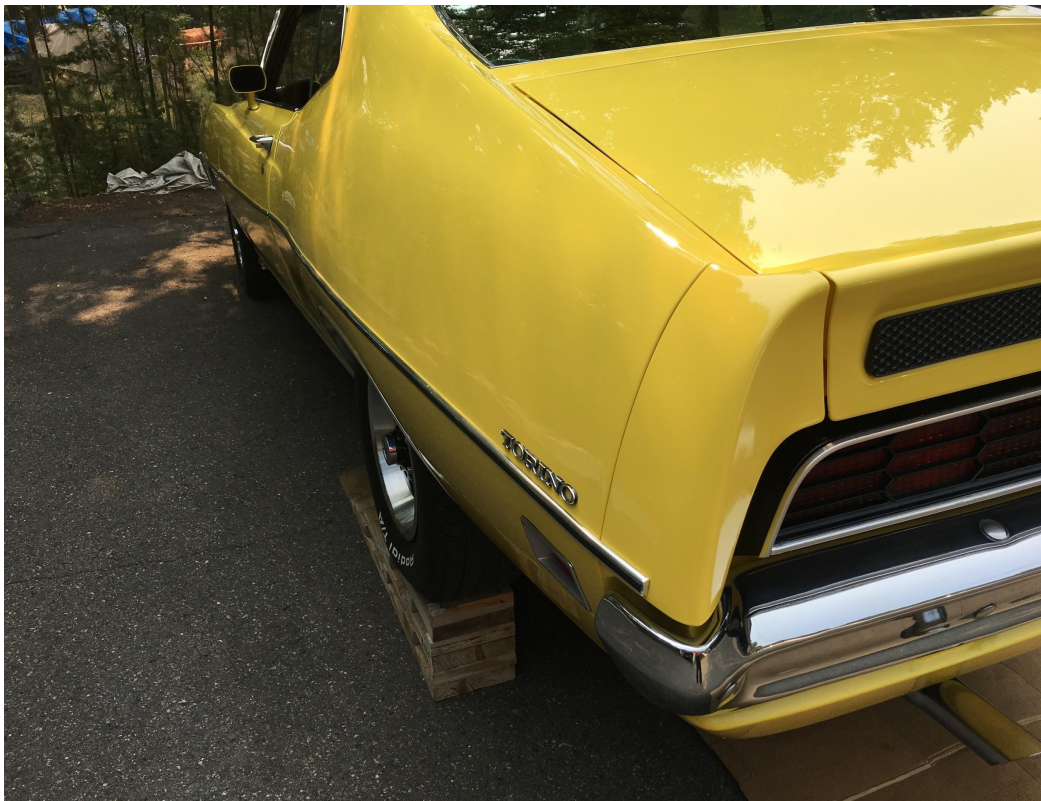
Smooth body panels, excellent detailing fit and finish

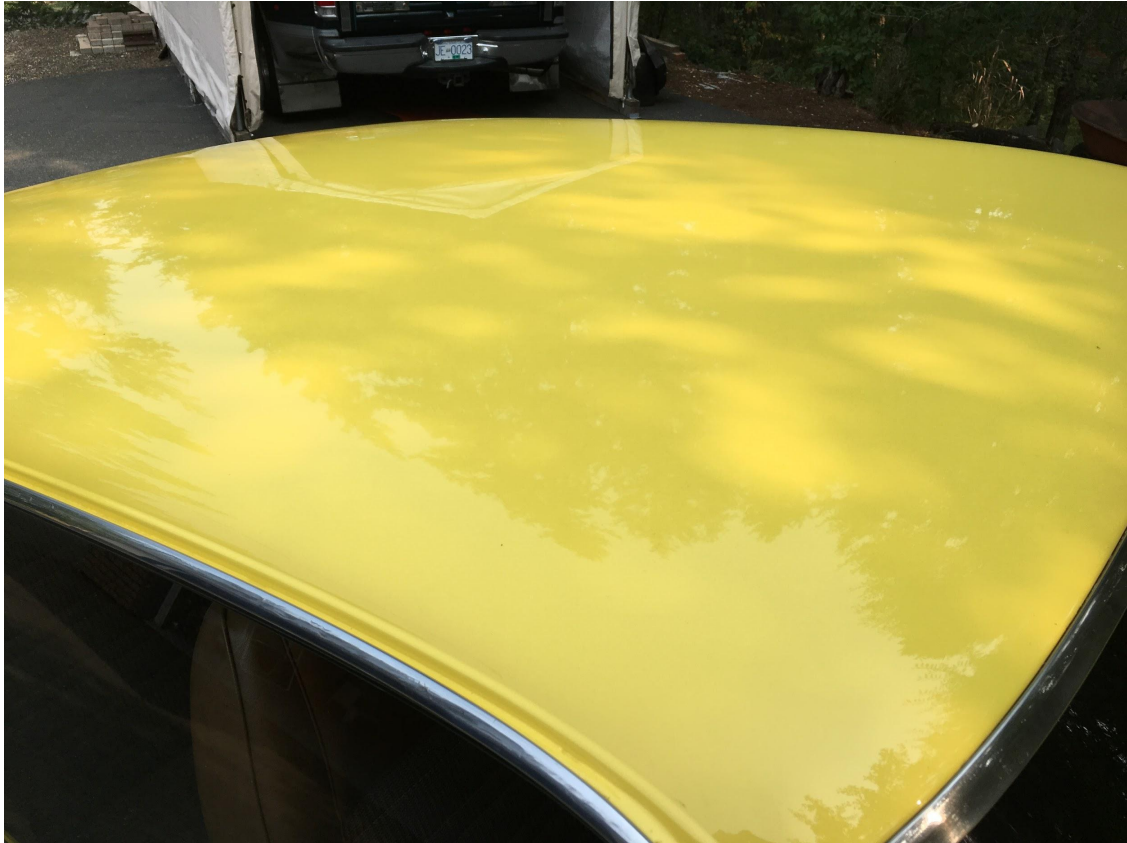
Roof smooth, good prep on channel details, some scratches on moldings

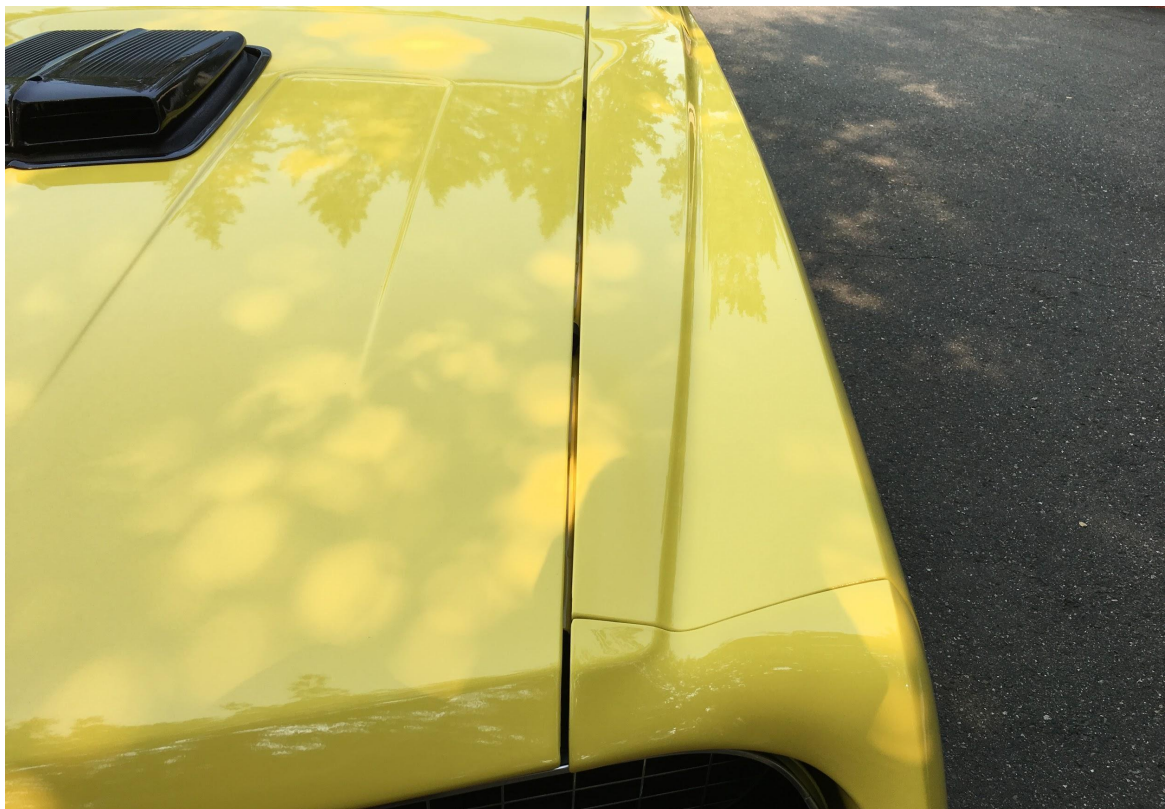
Body prep very good, fit and finish

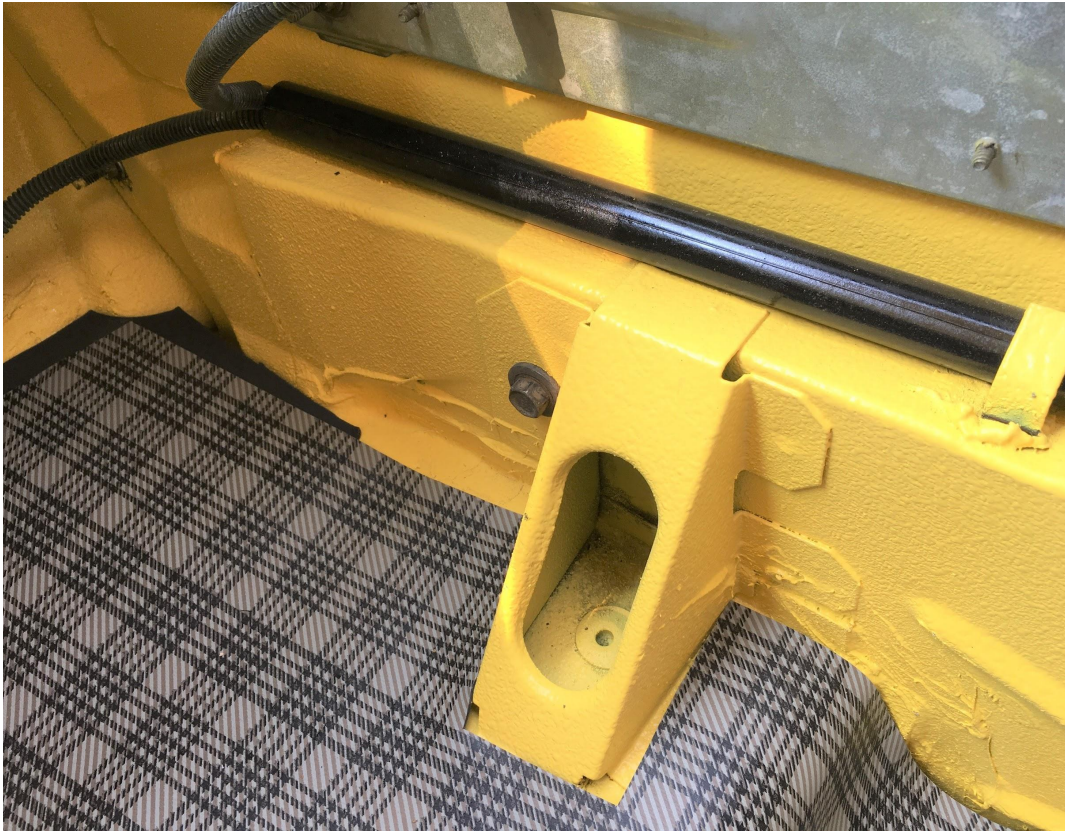
Rust

free trunk, repainted with body, new mat

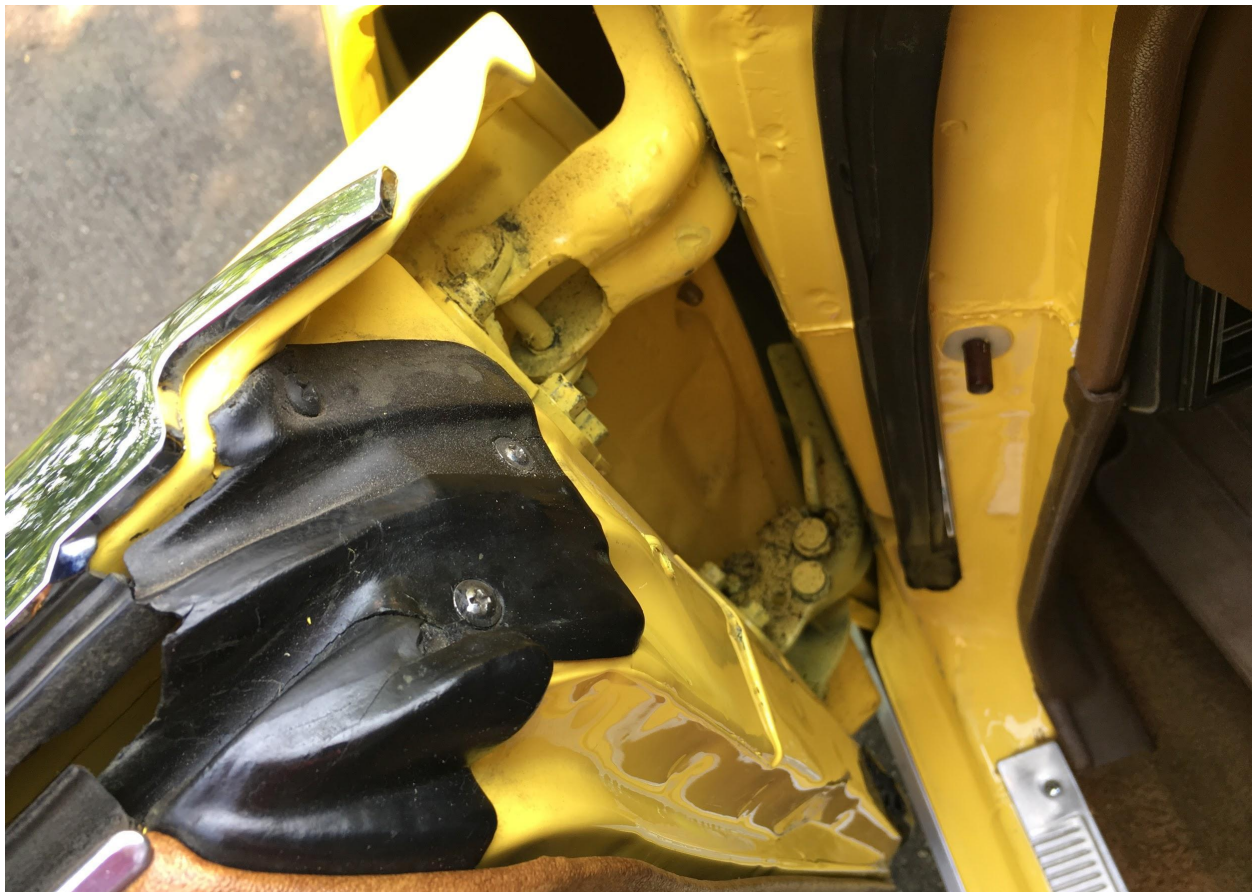
No

corrosion concerns in door frames, good jamb and hinge prep

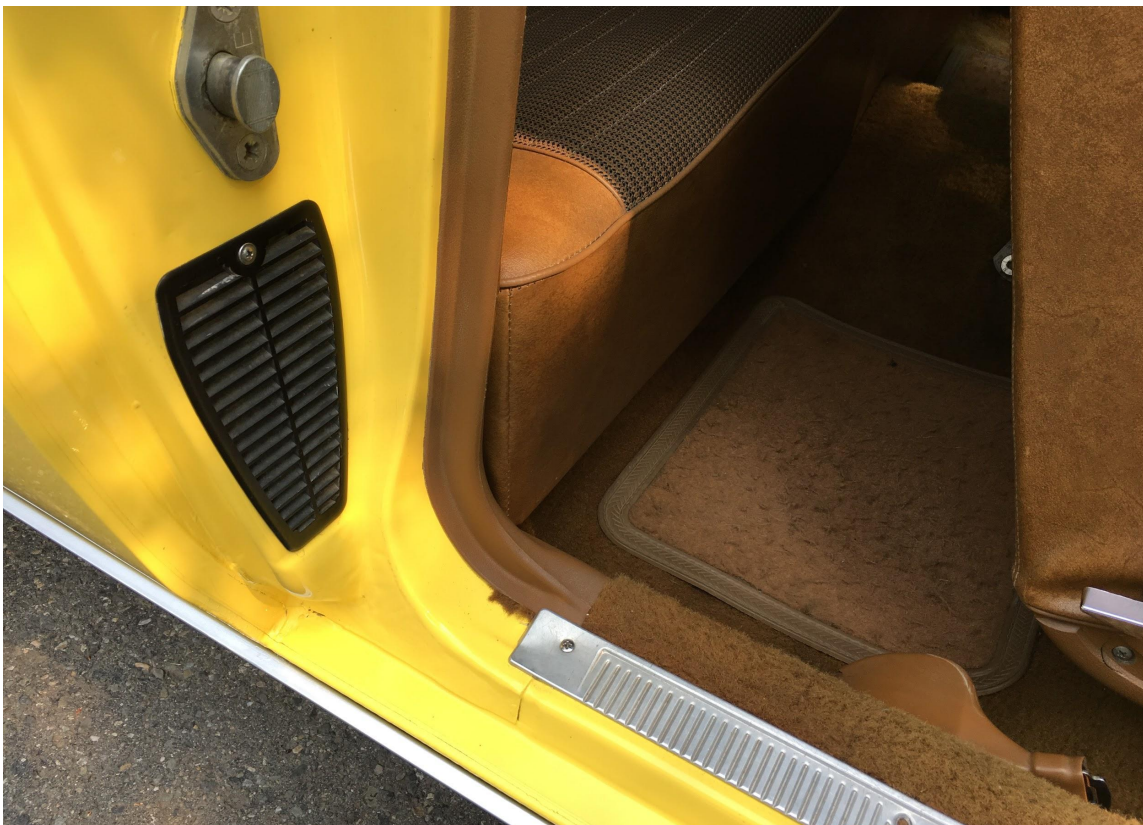
Clean door jams, excellent detailing in corners

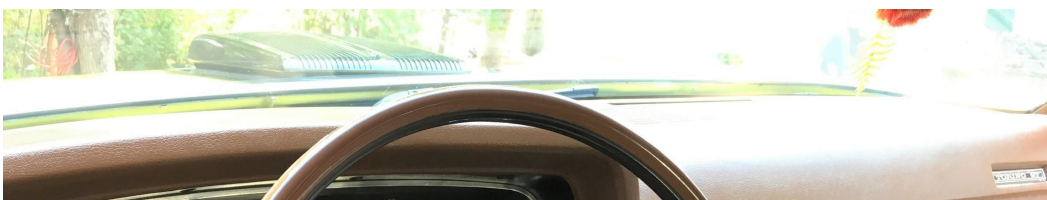
Steering wheel, instrumentation and tach in very good condition,

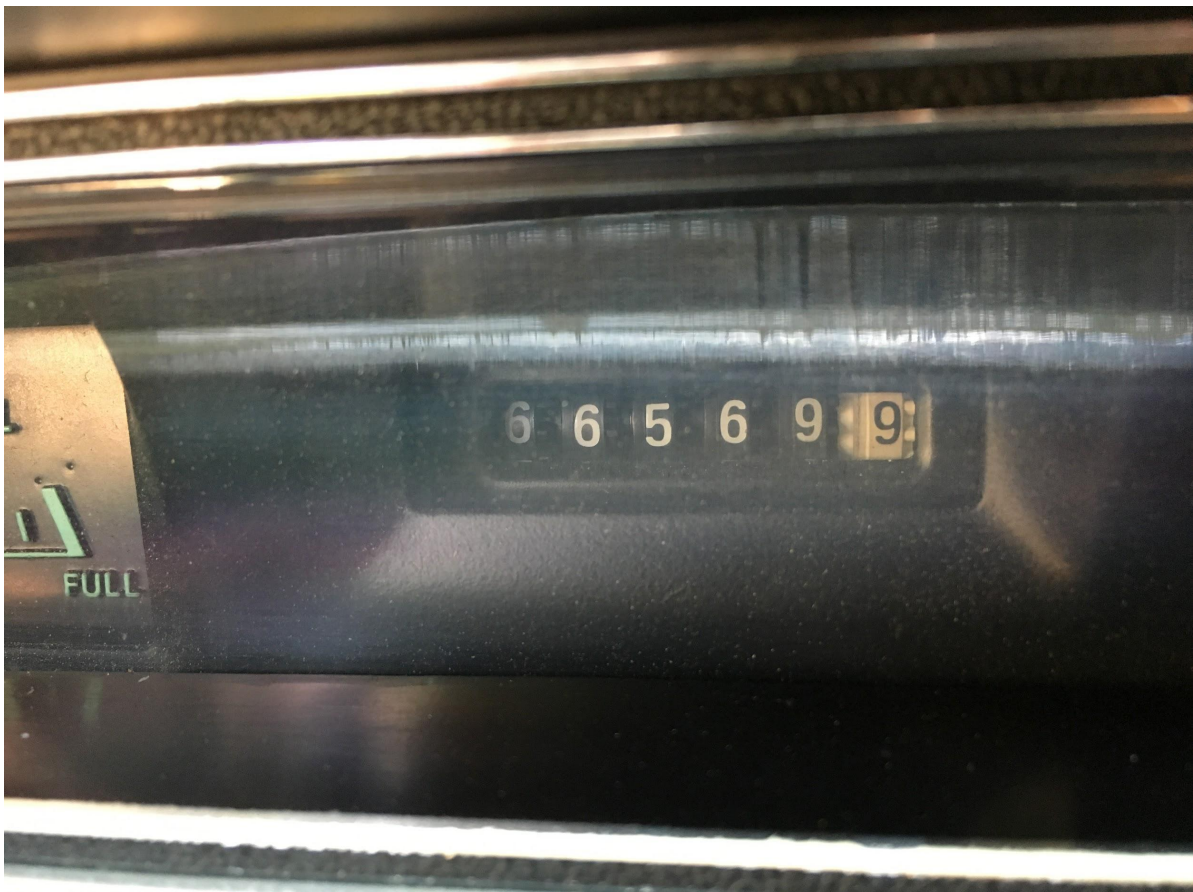
Odometer very low original 66,559 miles

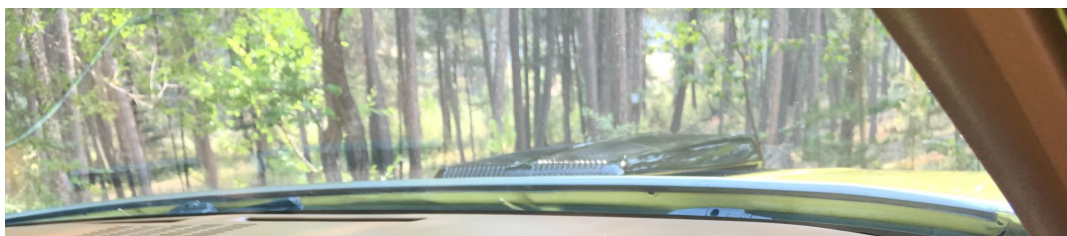
The original headliner was in excellent condition, as were the sun visors. There were some cracks and damage to the original dash panel, but it was otherwise in good condition. The dash instrumentation included the original speedometer and the fuel level and temperature gauges, all of which are operational. An aftermarket tachometer in very good original condition is attached to the steering column. All knobs are original and function correctly. The automatic transmission is operated from the selector on the center floor console, which was in excellent condition with a opening compartment for holding cassettes etc. The Rim-Blow steering wheel was in excellent original condition, other than not operating the horn. The car was nicely equipped with driver's convenience items including body-colour side view mirrors, windshield wipers, clock, electric rear defroster and glove box. There were some marks on the dome light molding. The kick panels under the dash were excellent condition with no scuffs.

Dash has a few damaged spots and cracks under Torino emblem

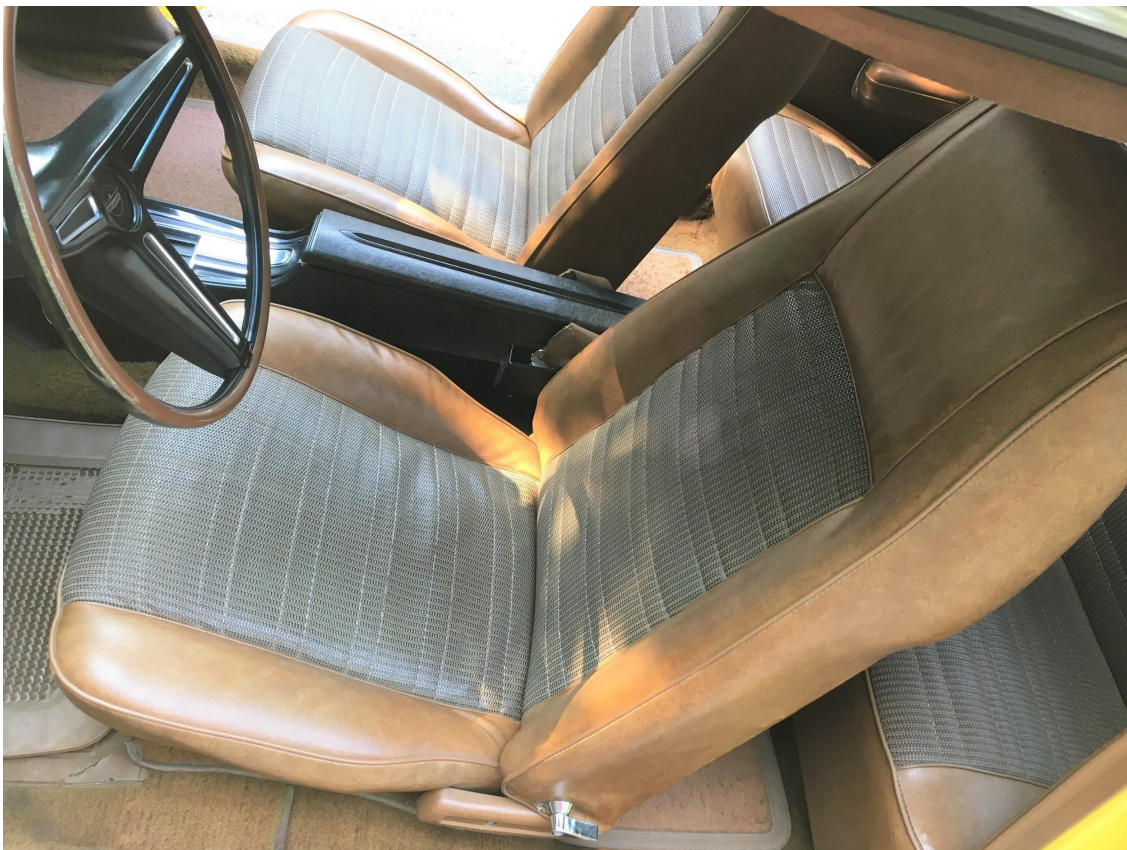
Original upholstery in very good condition, no rips or tears

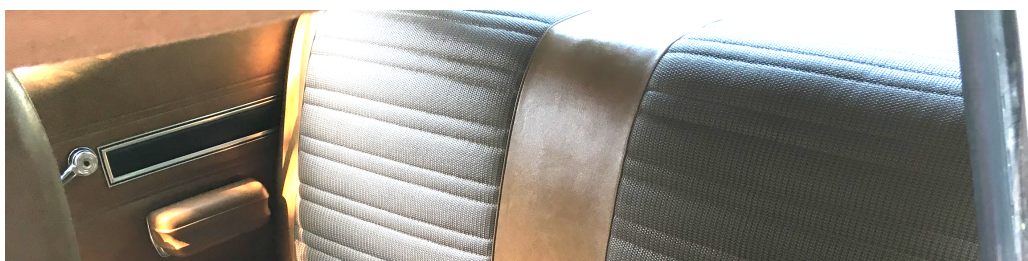
Back

seat area clean and as new

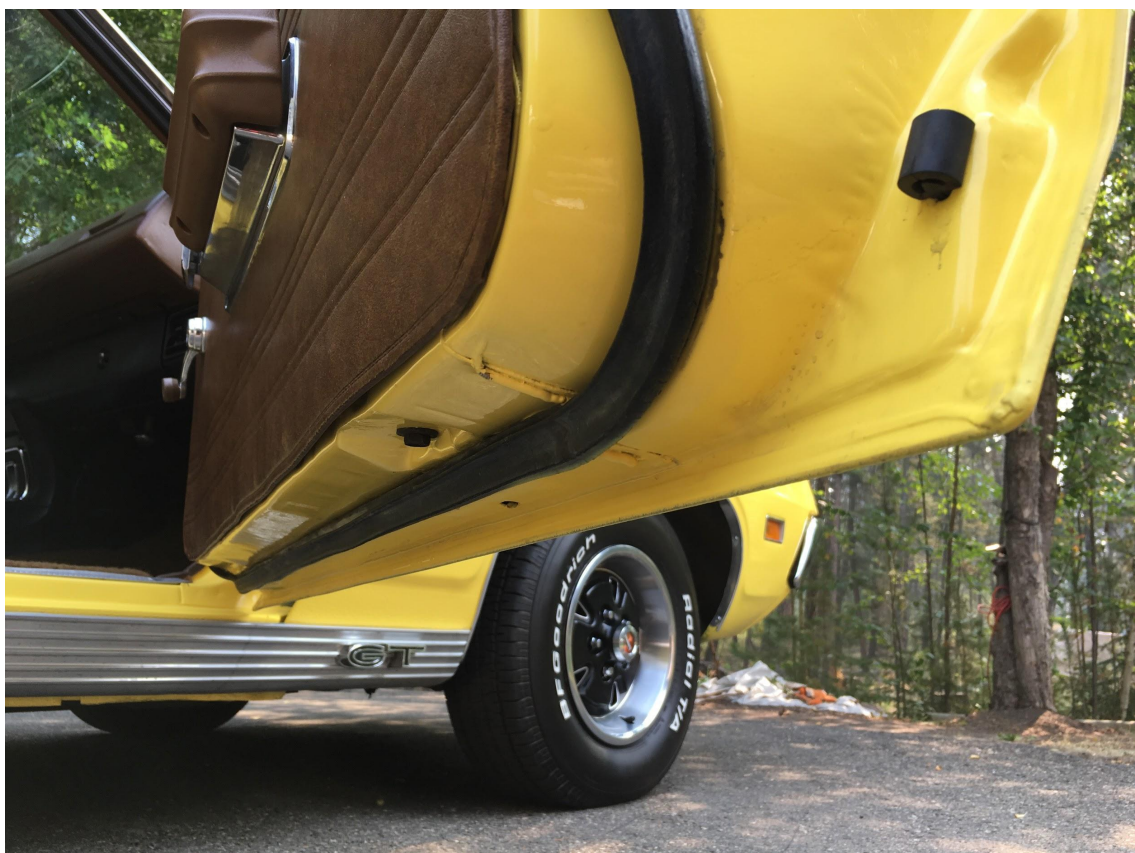
Door undersides very good, no corrosion or chips

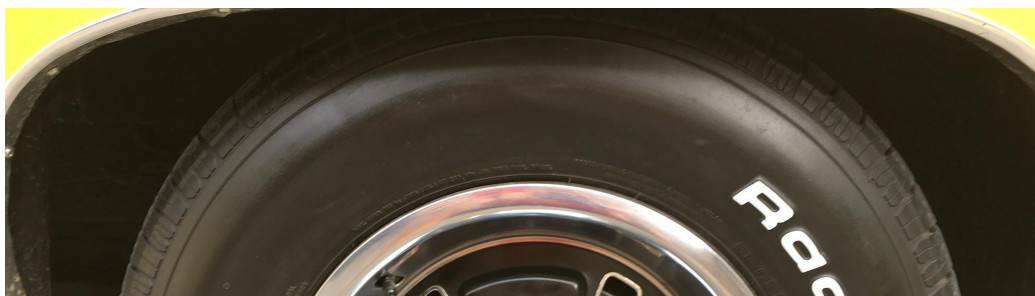
Original wheels in excellent condition, no dents or scratches, BFG tires

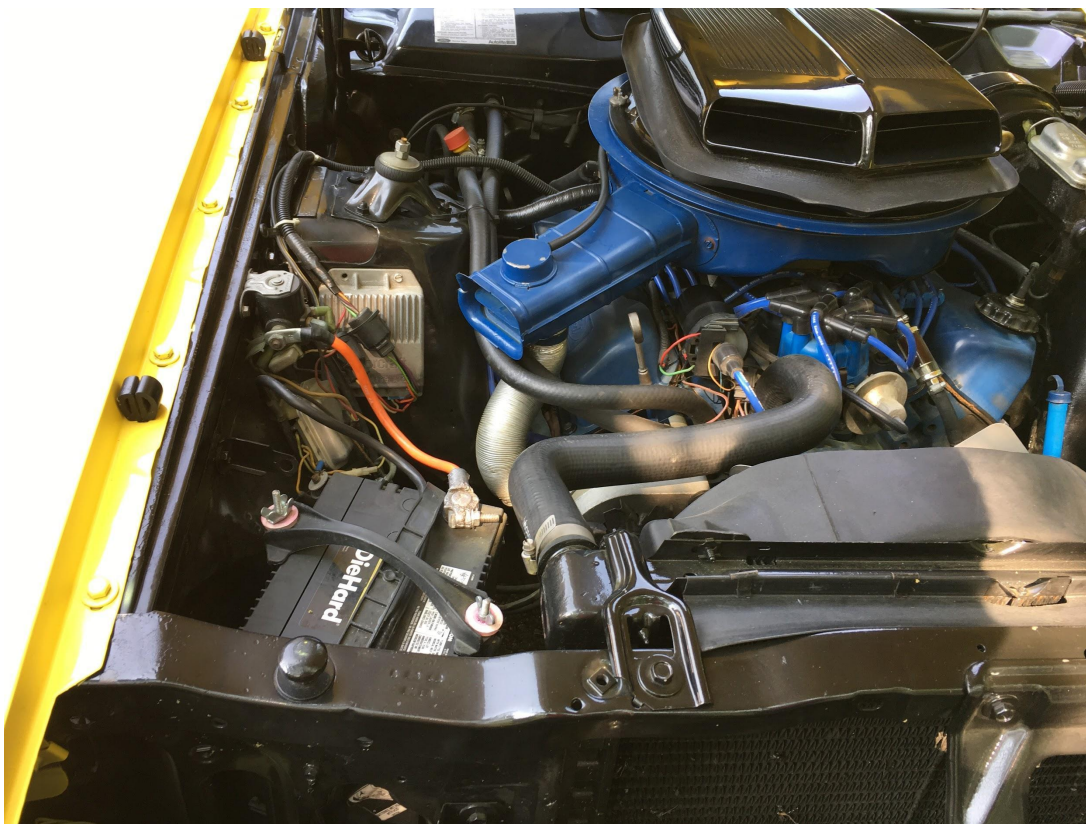
Original engine rebuilt, Ram Air, Shaker, new wiring and hoses, clean firewall

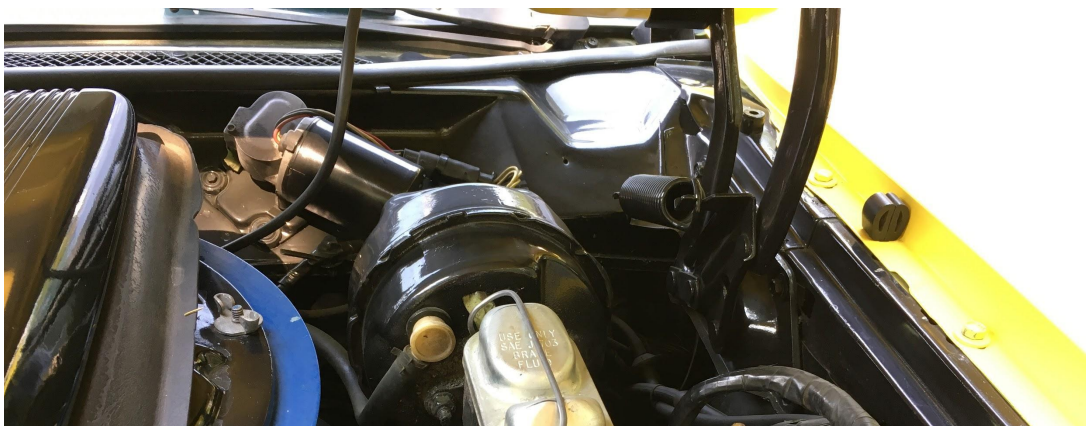
The vehicle retained its original configuration for suspension, with front disk and rear drum braking systems. The front and rear suspension bushings and shocks appeared in good condition except for some cracking in the top shock tower bushings, and the car shows no sagging. There was some surface corrosion on the bottom of the front crossmember and a tear in the steering stabilizer boot. All critical systems appeared to be in good working condition with no apparent problems. This summary is not a safety inspection and this report is not a qualification of the mechanical integrity of the components, but is only reporting on the visual state of what was present.

Clean inner fenders and seams, some cracks in shock tower bushing

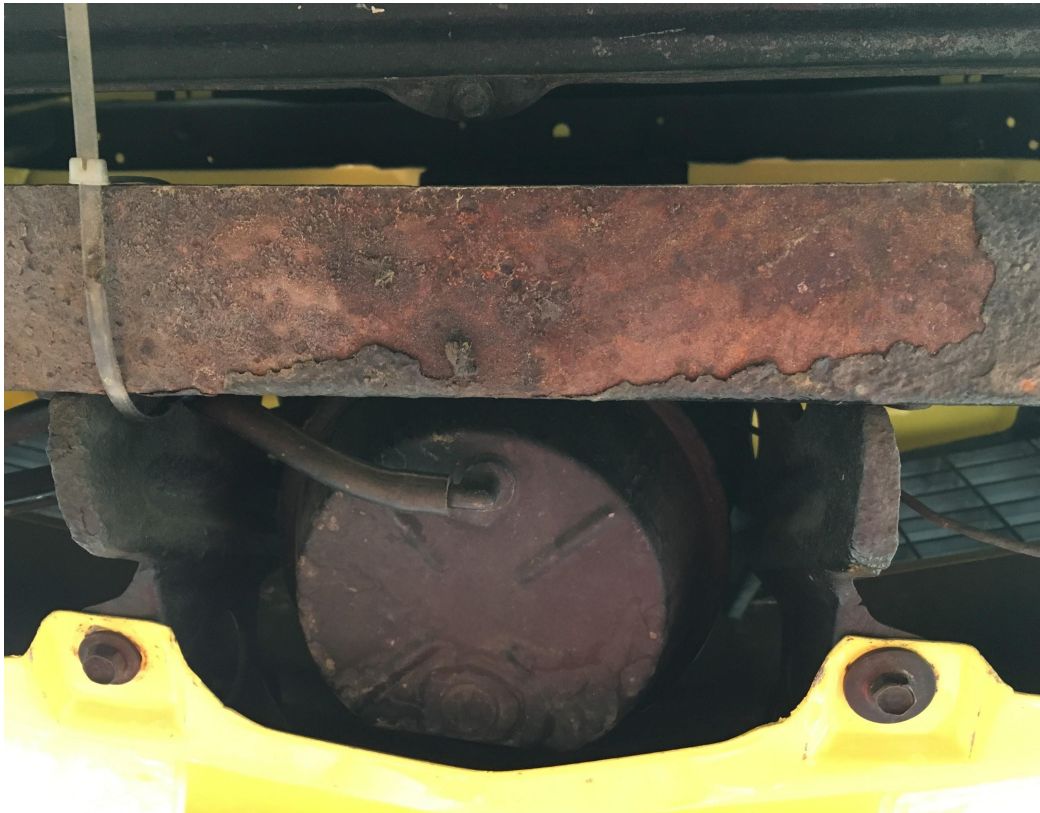
Front crossmember and rad support need some clean-up detailing

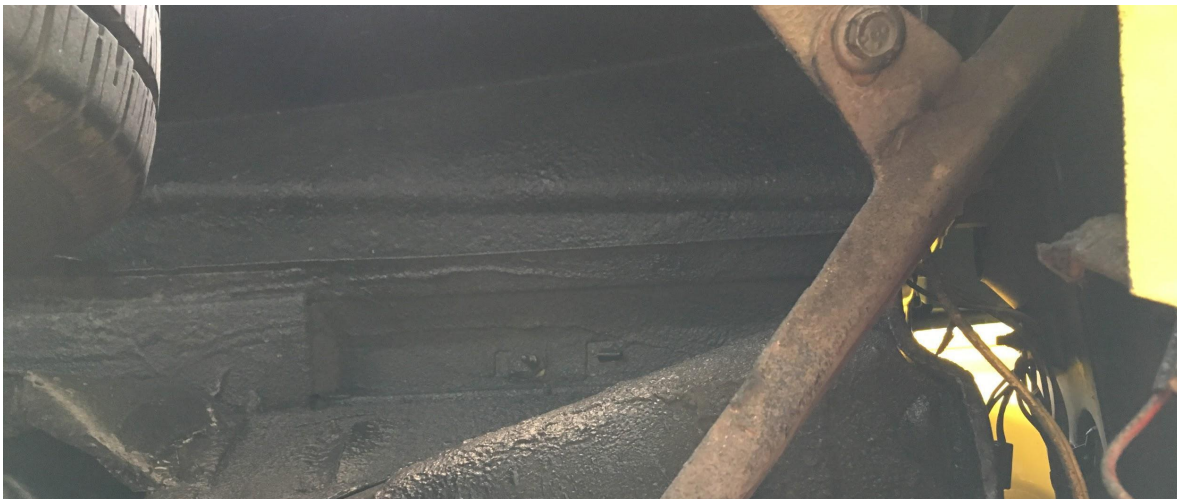
Inner fenders very clean, very minor corrosion on some underside components

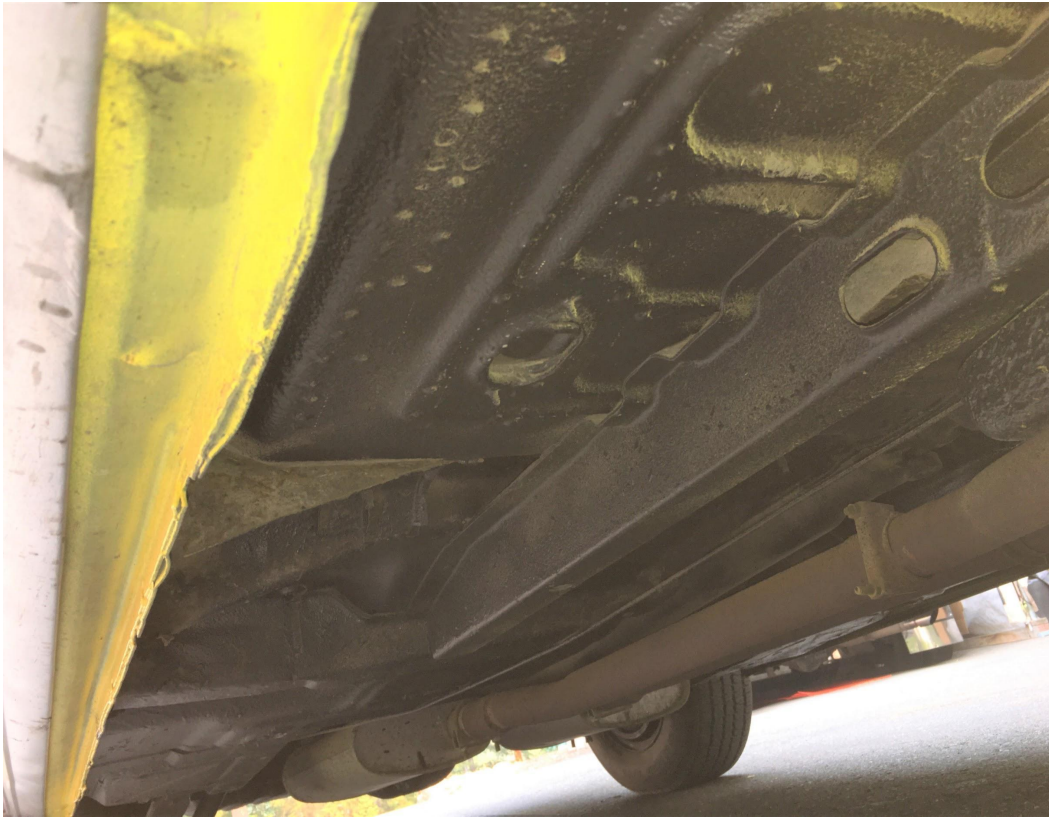
Very clean underside and rocker seams, minor overspray from rear

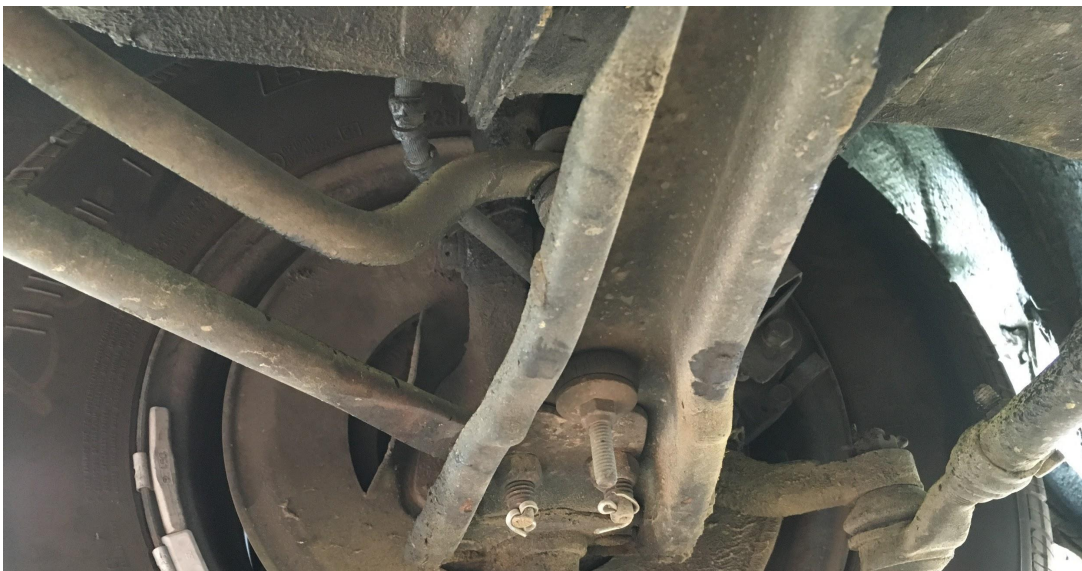
Front suspension bushings in good condition

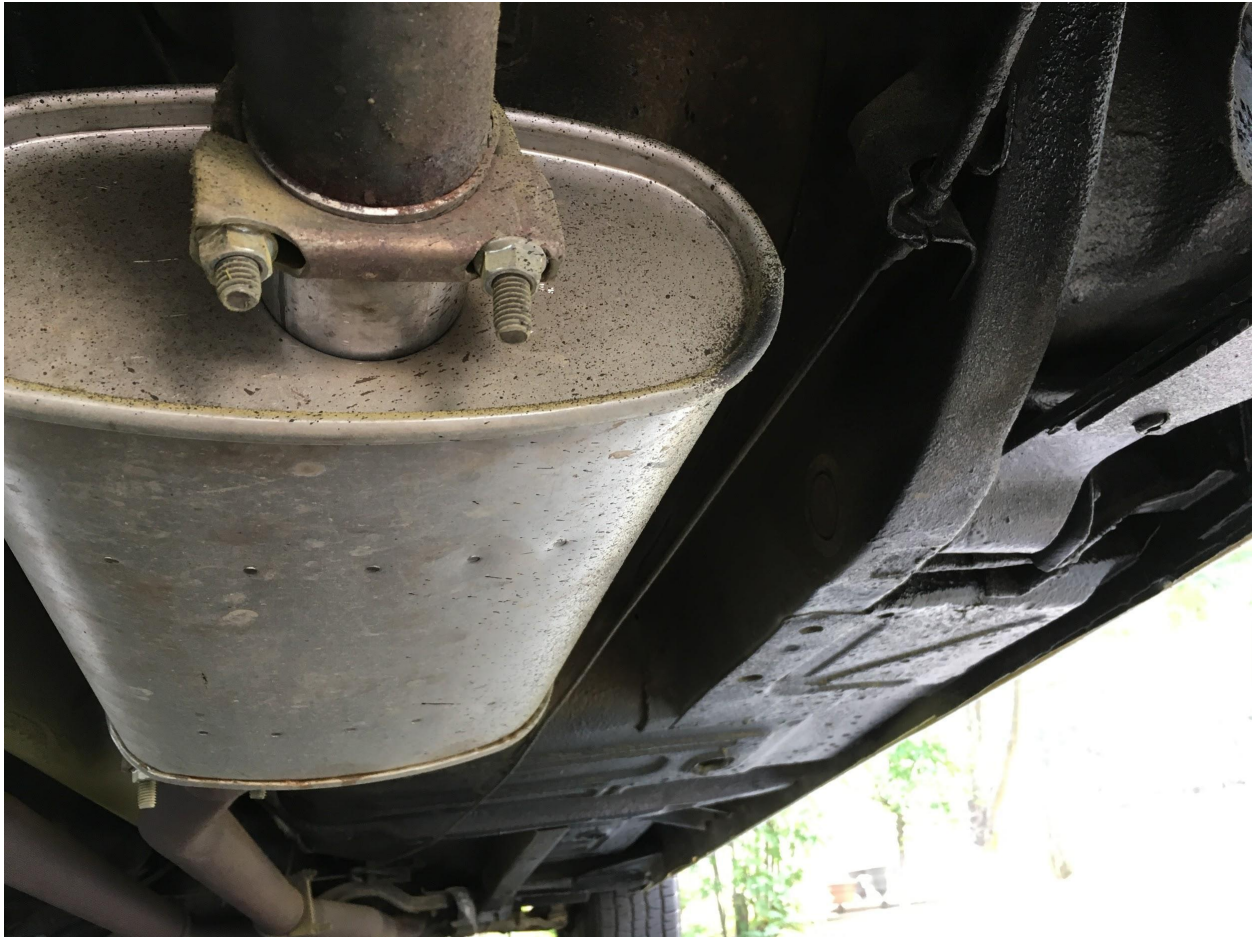
The frame and underbody is in excellent condition with only minor signs of surface corrosion in some spots. The exhaust system was the original dual configuration, and there was some surface corrosion on the exhaust pipes but not on the mufflers. There was no indication of any leaks in the system and when the engine was idling.

Air Underbody very clean, mufflers good, some exhaust pipe surface corrosion
